# Visual Illusion Results in Malfunction of Anesthesia Machine Sensors

by Steven Simon, Bryan Gaeta, CRNA, Enrique Pantin, MD, and Antonio Chiricolo, MD

CITATION: Simon S, Gaeta B, Pantin E, Chiricolo A. Visual illusion results in malfunction of anesthesia machine sensors. *APSF Newsletter*. 2023;38:2,57-59.

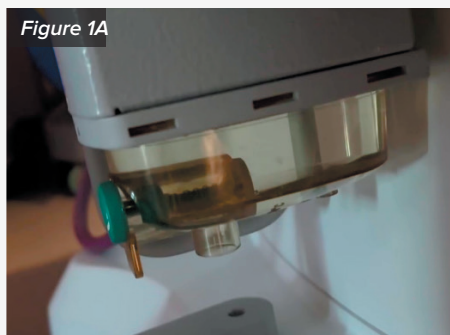
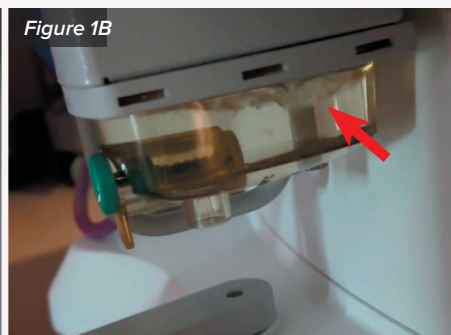
Figure 1: Exhibit A and B demonstrating the full condenser reservoir undisturbed (A) and the same condenser reservoir when shaken (B).

A further concern regarding the condenser reservoir is related to the design of the reservoir itself. With proper maintenance, water levels should never exceed the height of the transparent plastic that the reservoir is comprised of. However, as we have demonstrated, if the water level exceeds the level of the transparent plastic, the condenser reservoir may appear empty. We suggest that a consideration be made for modification of the reservoir with a means to easily determine if the reservoir contains any water. Possible modifications may include a float, the use of translucent plastic on the condenser walls, or the use of an electronic sensor that notifies the user if there is excess water accumulation in the reservoir.

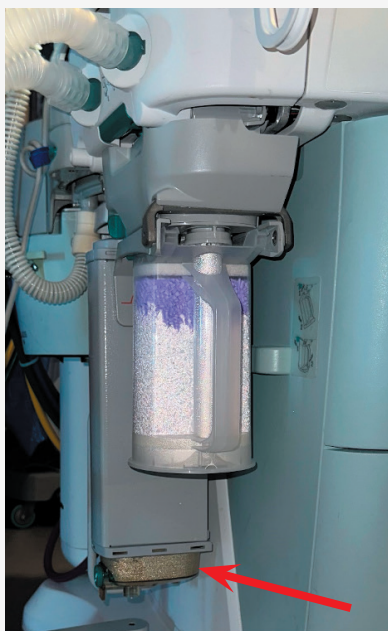
We would first like to recognize that proper maintenance according to the user's reference guide published by GE Healthcare recommends that operators visually inspect the condenser reservoir daily and drain it if needed. The condenser reservoir is located adjacent to the CO<sub>2</sub> absorbent canister and collects water from the breathing circuit. Drainage is accomplished by pressing the green drain button on the side of the condenser and allowing the water to drain from the opening underneath.<sup>1</sup> Appropriate maintenance is essential for the proper functioning of anesthesia equipment, and this incident further demonstrates that point. However, the aforementioned event raises several concerns regarding the location and the design of the condenser reservoir. The reservoir on the Avance CS<sup>2</sup> is located behind the absorber canister and is only a few inches above the base of the left lateral side of the machine as seen in Figure 2. Direct access to the left side of the anesthesia machine in the operating room is often blocked by various equipment and is typically in close proximity to the sterile surgical field. Even when approached from the front of the machine, the low and posterior location of the condenser

Figure 2: Location of the condenser reservoir on the Avance CS<sup>2</sup>.

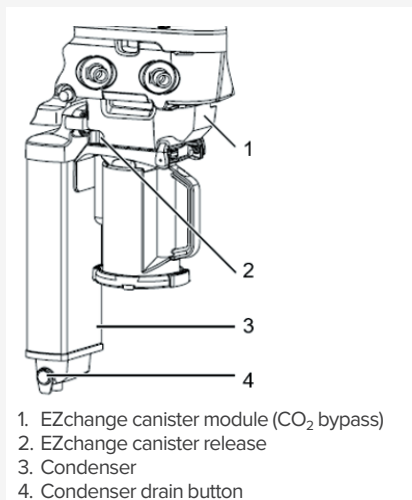
Managing humidity and water accumulation in the breathing system is necessary for all anesthesia systems. There are recommended strategies for minimizing water in the breathing system, as well as procedures that can be followed to eliminate the impact of water on the performance of flow and gas concentration sensors. With that goal in mind, the Avance CS<sup>2</sup> anesthesia system includes a condenser designed into the inspiratory flow channel to control water accumulation. See Figure 3.

Figure 3: Condenser Location.

- G. Visually check the condenser daily and drain the reservoir daily (See Figure 3)

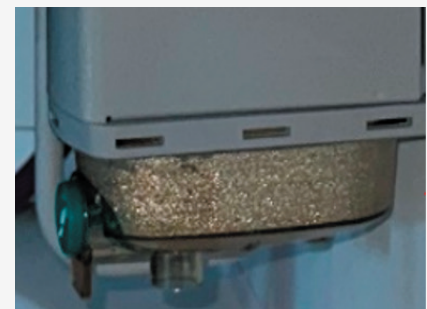
Adhering to the prescribed user care and maintenance instructions would minimize liquid water buildup in the condenser as observed at the Robert Wood Johnson Medical Center. When the condenser is in use and not full, condensation is visible on the walls of the condenser reservoir which serves as an indicator the reservoir is not full. See Figure 4. When condensation is not present during use, the reservoir drain should be opened to drain any accumulated water. While the condenser drain is located where it is not easily visible from a standing position, it is easily accessed from the front of the machine to visually check the water levels and drain the condenser daily. The drain

Figure 4: Reservoir Condensation.

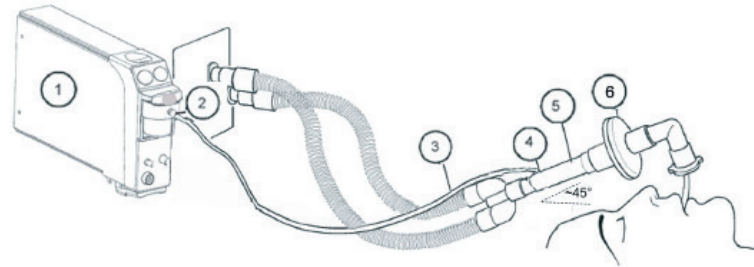
1. CARESCAPE respiratory module
2. Gas sample, gas sampling line connector on the water trap
3. Gas sampling line
4. Gas sampling line connector on the airway adapter; place the connector upwards
5. Airway adapter with sampling line connector
6. Heat and moisture exchanger with the filter (HMEF) (optional when sampled gas is directed to the scavenging system]

Figure 5: Gas Measurement Setup.

- A. Heat and moisture exchanger with filter (HMEF) between the patient and the breathing circuit to prevent exhaled water vapor from the patient reaching the breathing system. Even though this is considered optional as noted in the figure, it is useful for controlling water intrusion into the circuit.
- B. Ensure correct size and fit of accessories according to patient type and application.
- C. Ensure airway gas measurement setup is correct. See Figure 5.

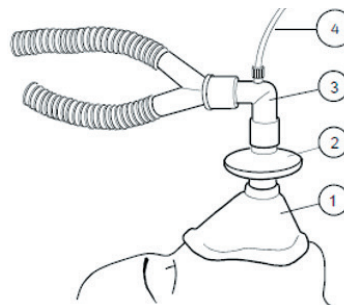
1. Mask
2. Bacterial Filter
3. Airway adapter
4. Sample line

Figure 6 – Gas Measurement Setup during mask ventilation.

- D. If using a D-lite/D-lite+ flow sensor, place all D-lite ports upwards with a 20° to 45° tilt to prevent condensed water from entering the sensor interior and tubing
- E. Use a D-lite+ flow sensor for high humidity conditions
- F. When using a mask and sampling patient gas, ensure the configuration allows water to drain away from the gas sample port. See Figure 6
